SOUTHWEST AIRLINES B737 WET RUNWAY OVERRUN DURING LANDING

based on NTSB Aircraft accident brief AAB0204, June 2002 & FSF accident prevention vol.60.no.7 July 2003

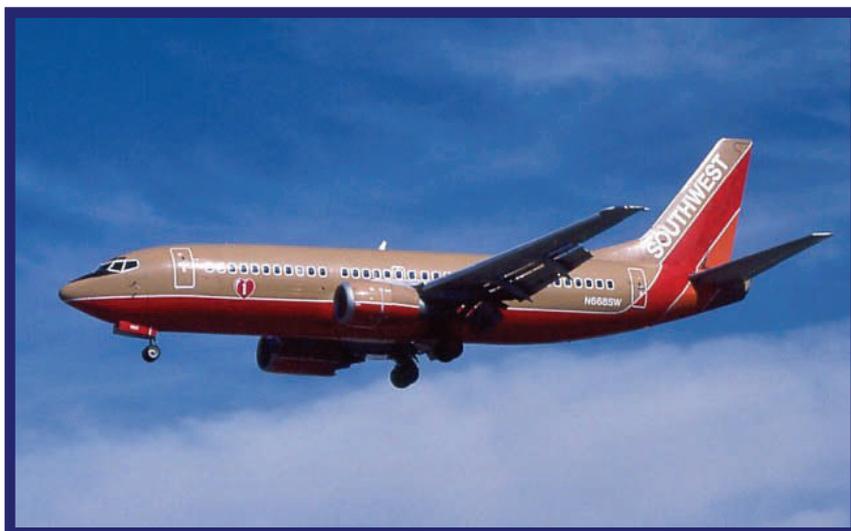
On March 5, 2000, 1811 Pacific standard time (PST), Southwest Airlines Flight 1455, a Boeing 737-300, overran the departure end of runway 8 after landing at Burbank-Glendale-Pasadena Airport (BUR), Burbank, California. The aircraft touched down at approximately 182 knots, and 20 seconds later, at approximately 32 knots, collided with a metal blast fence and an airport perimeter wall. The aircraft came to rest on a city street near a gas station off of the airport property. Of the 142 on board, 2 passengers sustained serious injuries; 41 passengers and the captain sustained minor injuries. The aircraft sustained extensive exterior damage and some internal

damage to the passenger cabin. During the accident sequence, the forward service door (1R)escape slide inflated inside the aircraft; the nose gear collapsed; and the forward dual flight attendant jump seat, which was occupied by two flight attendants, partially collapsed. The flight, which was operating on an IFR flight plan, was conducted under 14 CFR Part 121. Twilight lighting VMC conditions prevailed at that time.

The report noted that the aircraft structure was intact, and the entire airframe was accounted for at the accident site. Major damage was confined to the nose section (mainly on the left side and the nose wheel-well area), and a section of the fuselage which collapsed circumferentially. The nose gear was severed from the drag brace and driven aft into the electronics bay.

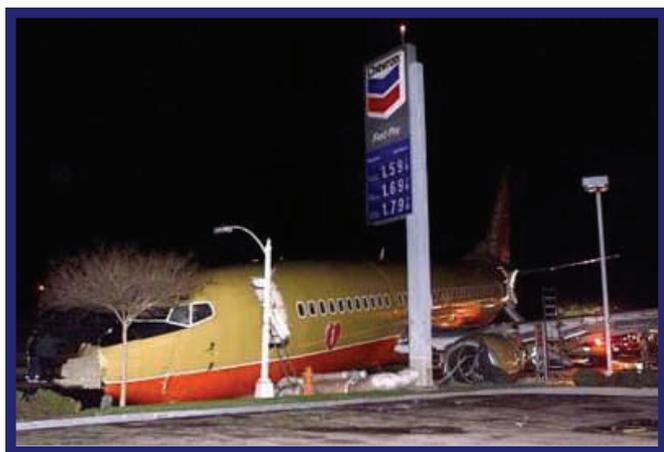
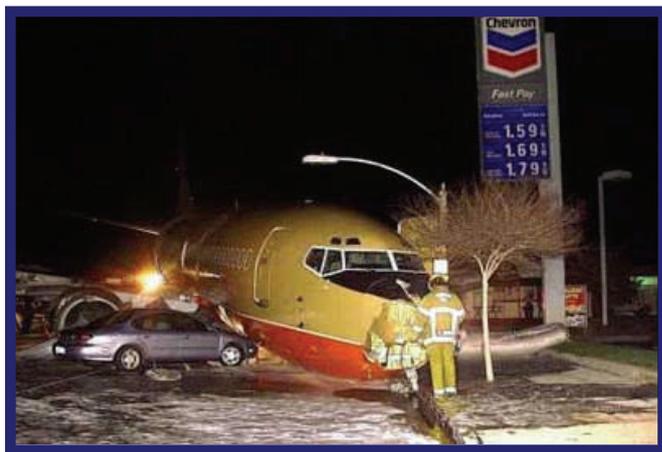
At 1811:20, the cockpit area microphone (CAM) recorded impact sounds. The aircraft departed the right side of the runway at 30° from the runway heading, penetrated a metal blast fence and an airport perimeter wall, and came to a stop on a city street off of the airport property.

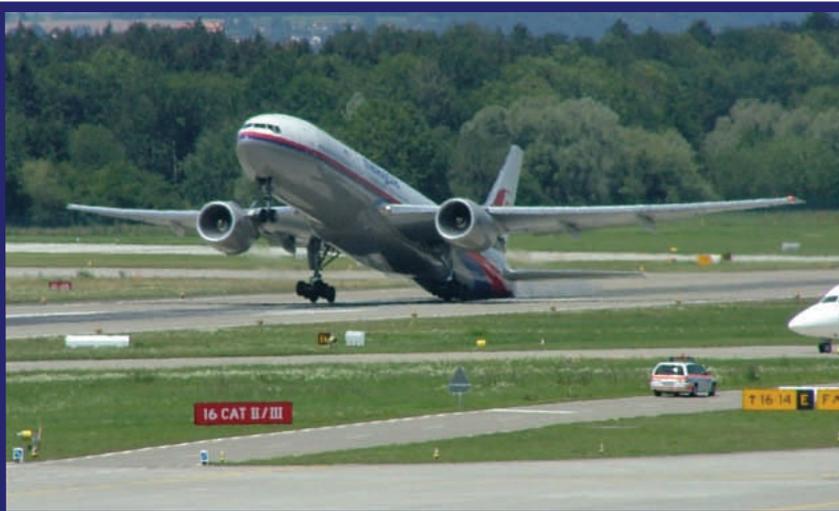
Tail strike during takeoff

On July 28,2004, Malaysian Airlines flight MA9, a Boeing 777-2H6(ER) while taking off from Zurich-Kloten airport LSZH, Switzerland, had a tail strike.

After dumping fuel for 40 minutes it made an emergency landing. There was damage to the fuselage aft structure. The aircraft is currently flying.
