A310 Rudder failure

On 06 March 2005, an Airbus 310-308, Canadian registration C-GPAT, serial number 597 operated by Air Transat, was on a charter flight from Varadero, Cuba, to Québec City, Canada, with a crew of 9 and 261 passengers on board. While at an altitude of 35 000 feet, the flight crew heard a loud bang with simultaneous vibrations that lasted a few seconds. The aircraft entered a *Dutch roll* (a periodic rolling and yawing snaking motion) which decreased as the aircraft descended to a lower altitude. Once the aircraft reached about 19 000 feet, the flight crew had no indication of any abnormalities from systems monitoring. The flight crew considered landing at Fort Lauderdale, Florida, but elected to return to Varadero where an uneventful landing was carried out. It is only once on the ground that the flight crew noted during a visual inspection that a major part of the rudder was missing. There were no fatalities. One flight attendant sustained minor injuries. This prompted manufacturer Airbus to issue a directive calling for field inspections of rudders on both A310 and A300-600 models. As a result, nearly 400 Airbus aircraft worldwide were affected. Air Transit susp

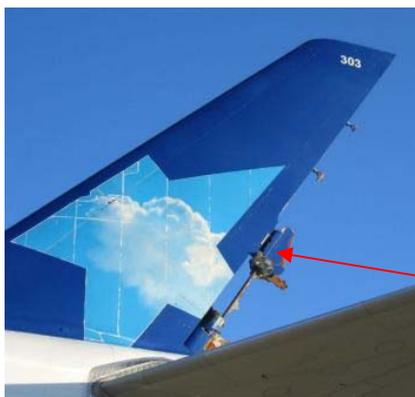
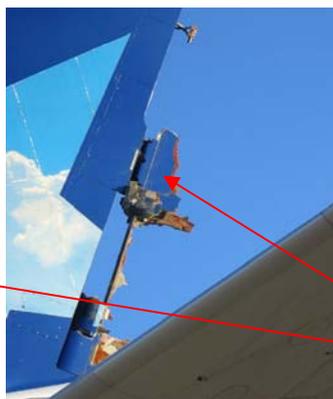
The investigation team observed that only the lower rudder spar and the base rib of the rudder were remaining. Less than five per cent of the total rudder surface actually remained attached to the spar. The rudder is attached to the vertical fin through seven A-frame hinges, numbered one to seven, starting from the bottom. The remaining parts of the rudder were attached to the vertical fin's rear spar by the actuators and the four lower rudder hinges. Hinges five and six were still in place on the fin spar, but only the attachment fittings of the rudder were attached to them. The rudder position sensor was still attached to the remaining piece of rudder. Rudder hinge number seven was torn off from the fin spar.

Two views of the rudder remaining

However, in the present case, the aircraft was at a cruising altitude where there is no need for aggressive rudder control. In fact, no crew inputs to the rudder were given throughout the flight. Yet the rearmost lugs holding the tailfin to the fuselage were damaged. The rear lugs, of the six that attach the fin to the fuselage, generally endure the greatest loads.

The vertical tail plane (VTP) and the rudder were transported from Cuba to Bremen, Germany, for further examination. The VTP, to which the rudder is attached, is bolted to the top of the fuselage by six attachment lugs. Ultrasonic inspection, of the VTP revealed delamination damage to the two rear attachment lugs.

Prof. Williams, an authority on composites from MIT, USA and other scientists have stated that composite parts in any aircraft should be tested frequently by methods such as ultrasound, allowing engineers to 'see' beneath their surface. Prof. Williams' research suggests that repeated journeys to and from the sub-zero temperatures found at cruising altitude causes a build-up of condensation inside composites, and separation of the carbon fibre layers as this moisture freezes and thaws. Among various scenarios, three are under investigation - rudder layers damaged by oil or glycol leaking onto the composite material; damage caused by lightning during a previous flight and damage occurred to the inside of the composite layers, which cannot be seen from the outside. The accident has brought in many issues - composite primary structure/controls, adequacy of inspections, pilot training etc. The investigation is still on.

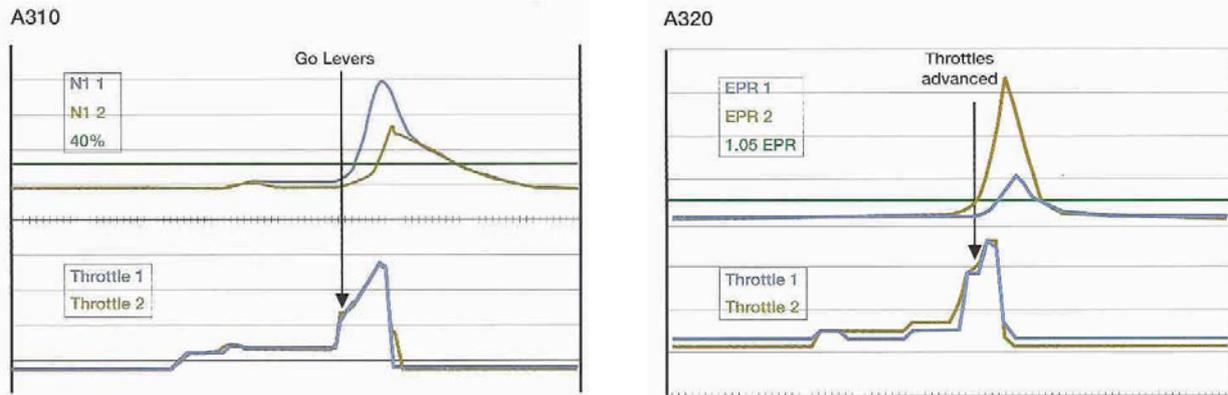
During the alignment on the runway centerline before takeoff, one throttle was advanced slightly above the other. This led to a situation where one engine was above idle. Then the go-levers were triggered (A310) or the thrust levers were advanced (A320) without prior N1 stabilization. The engine above idle accelerated faster than the other, leading to an asymmetrical thrust increase. In both cases, the takeoff was rejected but the aircraft left the side of the runway at low speed. DFDR data for the two cases are shown in the plots below.

To summarize, asymmetric power increases if the go-levers are triggered (A310) or the thrust levers are advanced (A320) without N1 stabilization while:

- One engine is at idle and the other is slightly above idle
- One engine is slower to accelerate than the other.

A310: - Slightly advance throttles and monitor spool-up until both engines are above idle (approx. 40% N1) OR
- Slightly advance throttles and monitor spool-up until both engines are aligned and stabilized between 1.05 and 1.10 EPR with no more than 0.002 EPR difference between both engines.

COMMUNICATION TO THE PILOTS: It is important to emphasize the understanding of engine response at takeoff thrust setting, particularly the requirement of setting a similar N1 (or EPR) on both the engines, prior to setting the takeoff thrust during type rating and recurrent training.
