# FLIGHT SAFETY

Vol.2, No.6

June 2007

## MK AIRLINES B747 REDUCED POWER TAKE-OFF AND COLLISION WITH TERRAIN

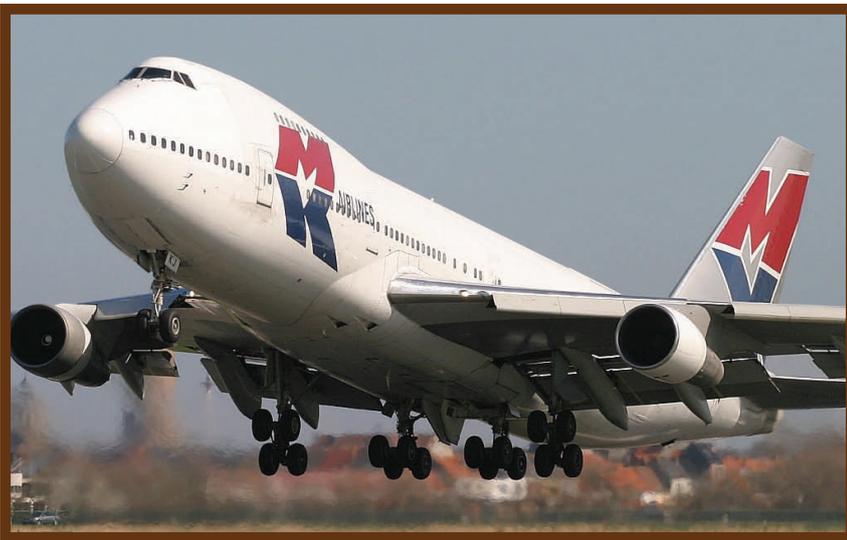
At 0653 UTC (0353 local time) the crew began the takeoff roll. During rotation, the aircraft's lower aft fuselage briefly contacted the runway (See the takeoff sequence figure in page 2).

A few seconds later, the aircraft's lower aft fuselage contacted the runway again but with more force. The aircraft remained in contact with the runway and the ground to a point 825 feet beyond the end of the runway, where it became airborne and flew a distance of 325 feet. The lower aft fuselage then struck

an earthen berm supporting an ILS localizer antenna.

The aircraft's tail separated on impact, and the rest of the aircraft continued in the air for another 1200 feet before it struck terrain and burst into flames. The final impact was approximately 2500 feet past the departure end of Runway 24, at an elevation of 403 feet ASL.

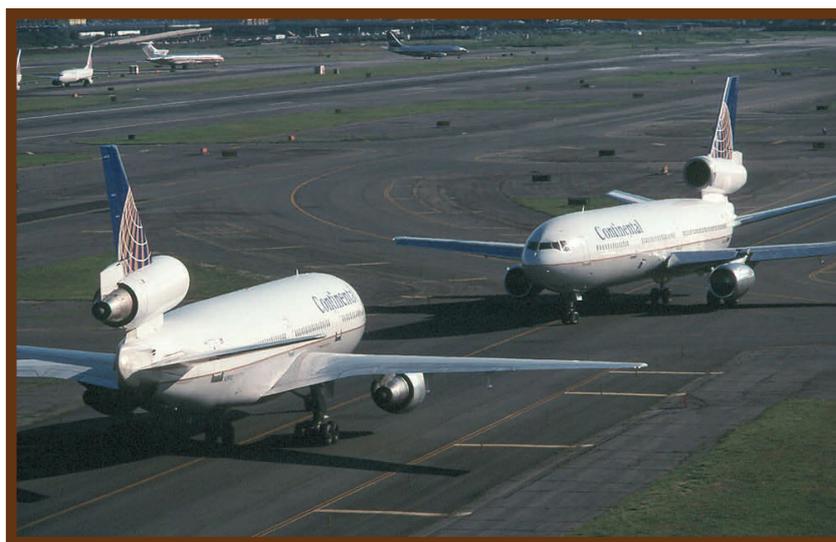
Runway incursion?! Who is at fault? What went wrong?

Runway incursion remains a significant risk to the safety of aircraft. Runway incursions have multiple causal factors generally involving flight crew, Air Traffic Controllers (ATC) and airfield operations.

Many times Incursions occur due to the non adherence or misinterpretation of ATC instructions. In a recent incident, a Virgin Atlantic Jumbo missed a SkyWest Brasilia within 50 feet at LA as SkyWest took a wrong turn violating a safety zone.
