Introduction

A320 Landing gear failure

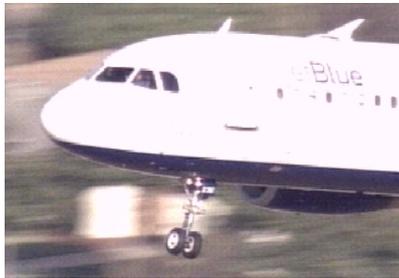
Nose gear stuck at 90 deg. offline in flight

On Sept.21, 2005, JetBlue flight 292 an A320 left Burbank, California on a transcontinental flight to New York JFK. Shortly after take-off, the pilot was unable to retract the nose landing gear and there were two warning lights indicating problem with the nose gear shock absorber and the steering system. The pilot informed the ATC and the aircraft was vectored to Long Beach airport over which it did a low fly-by and the Jet Blue maintenance staff there confirmed that the nose gear had turned sideways by 90 deg. off the center line which was the reason for the inability to retract.

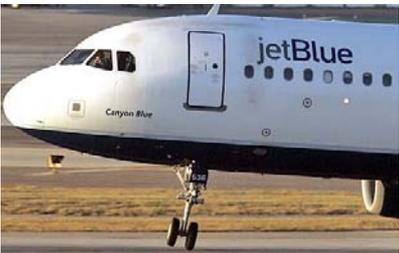
A split second before the nose gear touches the runway

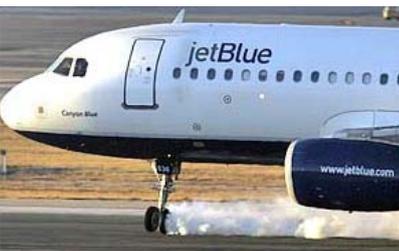
Nose rear tire is dragging and about to catch fire

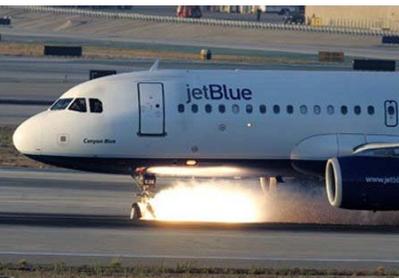
Nose rear tire is on fire from the heat generated by friction

Once the decision to land was made and emergency equipment was in place along the runway, the pilots brought the aircraft down on to runway 25L at 120 Kts about 2500ft down the runway. The plane rolled along the runway on main gear as long as possible as its speed decreased. After about 15 seconds the nose gear touched the ground. The gear's rubber tires rapidly shredded away until the metal hubs scrapped the runway pavement. The friction sent a trail of white smoke followed by a shower of sparks and finally the bright flashes of flame due to the burning of rubber tires.

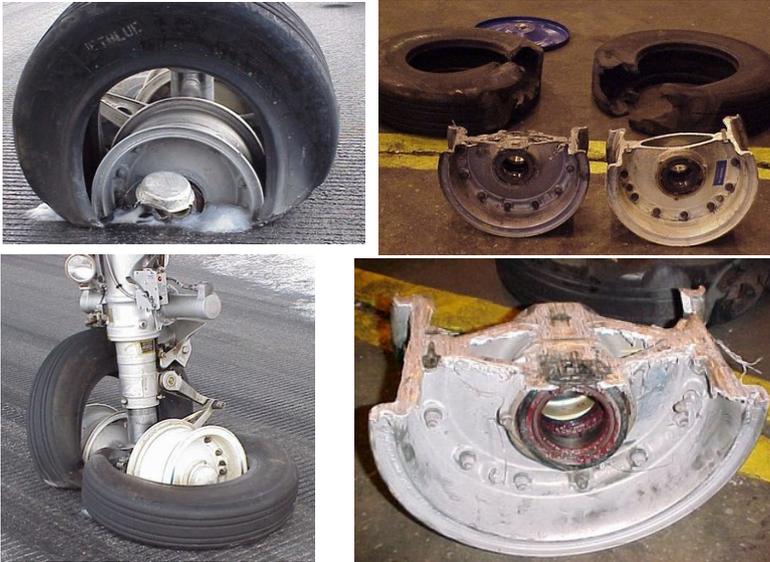
The investigation photos alongside show the damage of the tires and the wheel rims. The wear out of the two wheel rims can be seen clearly. This A320 was only three years old and had been through a routine maintenance check just five days prior to this emergency. NTSB, USA has said that the investigation could last about six to nine months.

As mentioned earlier, in all these cases, the steering control module seems to be the culprit. As per Airbus " during landing gear extension, the brake and steering control unit (BSCU) would have been energized and hydraulic pressure would have been directed towards the steering servo valve. The BSCU would have then commanded a small rotation of the nose wheel to check for proper movement. Any disagreement between the commanded position and actual position of the nose wheel would have deactivated the nose wheel steering. However, if hydraulic pressure had bypassed the steering control valve, there would have been continued pressurization to the servo valve, and because of the servo valve's inherent

offset, in-flight rotation of the nose wheels occur. Procedures existed for removal of hydraulic pressure from the steering control module. However, once the nose wheel strut had deflected 90 degrees, the centering cam would have been rotated to a flat area, and would have been incapable of overriding the 3000 Psi hydraulic system, and returning the nose wheels to a centered position.”

During the servicing and reassembly of the shock absorber, improper seating of the upper centering cam and consequently mating of the lower cam and the anti-rotation lugs results in the anti-rotation lugs at the upper end of the strut not being properly engaged in the backplate slots. The manufacturers of shock absorbers, Messiers-Dowty have found two additional incidents involving mis-assembly of the NLG shock absorber, one with Canada 3000, A320 and the other occurred in Ireland.

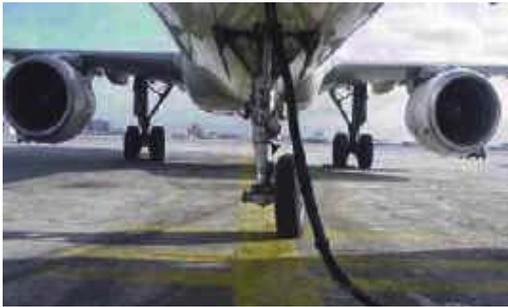
Missing wheel on the nose gear

close up of axle fracture

According to a study by the Transportation Safety Board of Canada (TSBC), the nose wheels of A-319, 320 and 321, also have a problem of nose wheel bearing failure. The investigation by TSBC was triggered by a failure on an Air Canada airbus in which the nose wheel broke off due to bearing failure. It is not certain as to why the bearings fail and the wheels fall off, but it is suspected that it is a combination of bearing material, the type and amount of grease used for lubricating the bearings. Proper tools and proper torques of the bearing nuts seems to play an important role. The Canadian report quotes “ the investigation of these occurrences did not reveal a definitive determining factor. Various modifications have been done to resolve this type of occurrence: stiffening of the nose wheel axle with a steel sleeve, a spacer inserted between the nose wheel halves, and a larger nose wheel to accommodate larger wheel bearings. These reduced the frequency of failure, but did not completely eliminate it.
