FLIGHT SAFETY

EXCEL AIRWAYS B737 TAKEOFF INCIDENT

Based on AAIB Aircraft Accident Report No: 3/2006 (EW/C2003/07/04)

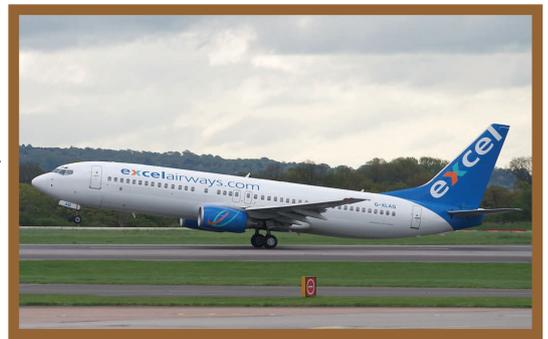
On July 16, 2003, at 1408 hrs. UTC, a Boeing 737-86N (G-XLAG) of Excel airways, was operating as a charter flight, flight number XLA 2146, from Manchester Airport to Kos in Greece, with a total of seven crew and 190 passengers on board. Runway 06L was in use but *the flight crew were not aware that it was being operated at reduced length*. This was due to work-in-progress to remove rubber deposits at the far end of the runway, which was out of sight from the 06L threshold end as the runway is built over a slight rise in the ground. Due to a difference in interpretation of information passed between Air Traffic Control (ATC) and the flight crew, the aircraft entered the runway from holding point AG, rather than the expected holding point A (see the runway plan below), and the takeoff was conducted using a reduced thrust setting calculated for the assumed normal runway length. *As the aircraft passed the crest of the runway, the flight crew became aware of vehicles at its far end but, as they were now close to their rotation speed, they continued and carried out a normal takeoff. The aircraft*

runway. The crews of all three aircraft were unaware of the reduced length available and, when informed, stated that it was insufficient for them to be able to land.

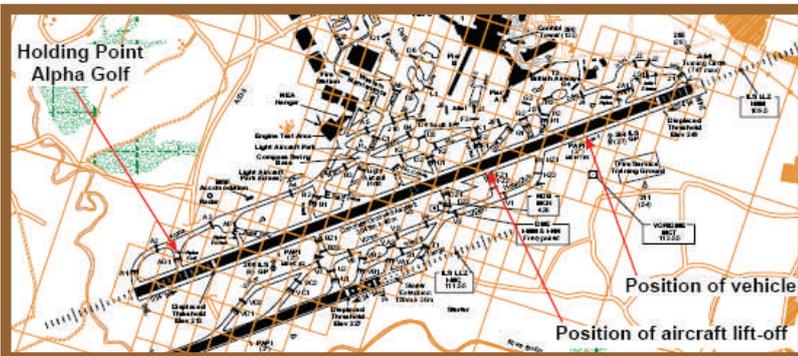
passed within 56 ft of a 14 ft high vehicle.

- Seven vehicles associated with the work-in-progress were on Runway 06L at the time of takeoff; closest to the aircraft's point of rotation was a rubber removal vehicle 14 ft high.

- After becoming airborne, the aircraft passed within 56 feet of the vehicle.

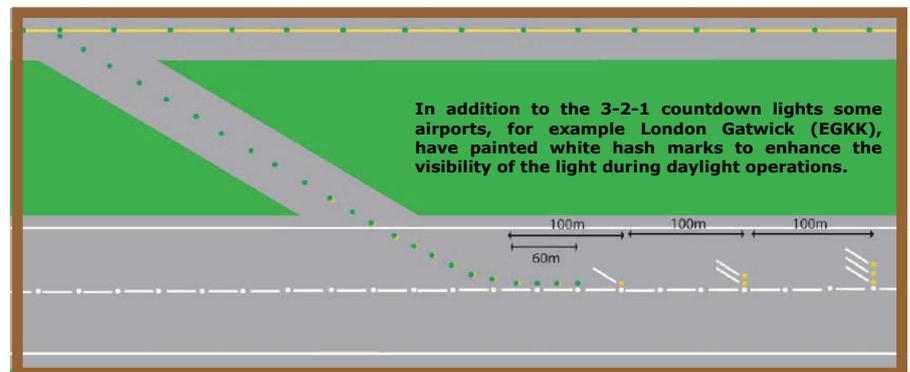
Because of the oblique design of RETs, this practice exposes the crews to a very real possibility of a runway incursion or worse because of the difficulty in seeing traffic either on the runway at the threshold which may be on a take off run, or traffic on final for the runway. Crews are encouraged to decline the use of any taxiways as departure points unless a completely

Capacity is important, however, safety is paramount, and therefore pilots should exit runways at a speed that is reasonable and safe for the prevailing conditions as well as the RET geometry and width but in any case this should be at a speed that is appropriate to the conditions.
