A320 Roll Control Problem

Based on BFU Investigation report no. 5X004-0/01 April 2003

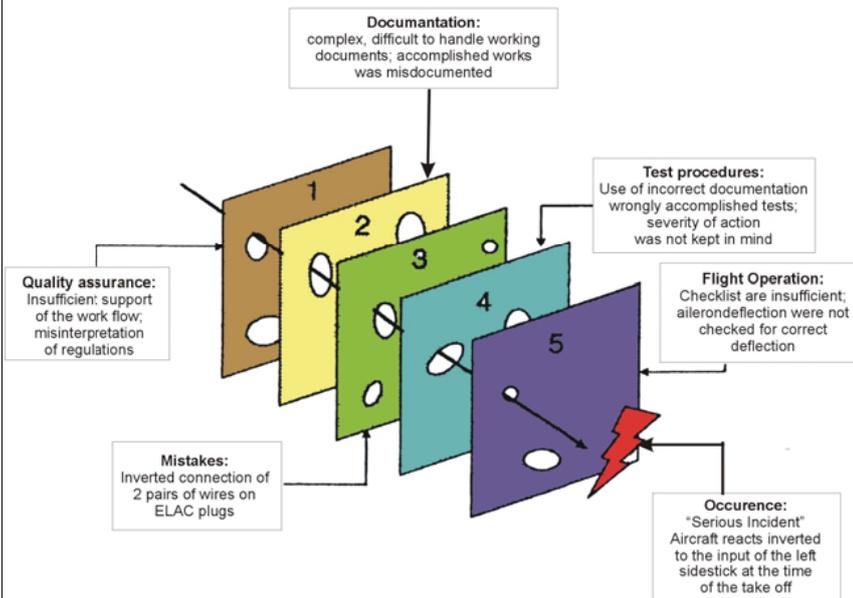
The serious incident is due to the fact that during repair work on the plug of the Elevator Aileron Computer (ELAC) no. 1 two pairs of wires had been connected inverted which remained undetected and the error was not recognized by the flight-crew during the “FLIGHT CONTROL CHECK”.

- An unclear and difficult to handle documentation so that a wrong wiring diagram was used
- Diversion from the manufacturer’s data by the Maintenance Support
- Manufacturer’s instructions which are not formulated unambiguously
- Functional check by the cross checking staff member was carried out incorrectly
- Insufficient functioning of the Quality Assurance
- The lack of supervision of the maintenance organization by the operator
- A quantitatively and qualitatively insufficient supervision of the maintenance organization and the operator by the supervising authority.
- Deficiencies in the “AFTER START CHECK-LIST” for the conduct of the “FLIGHT CONTROL CHECK”.

The causal chain that went uninterrupted in

precipitating this serious incident is illustrated above in the form of Swiss cheese model modified to a chronological sequence.
