FLIGHT SAFETY

AN IN-HOUSE NEWSLETTER OF OPERATIONS DEPT.

May 2009

TALE OF TWO TAILSTRIKES

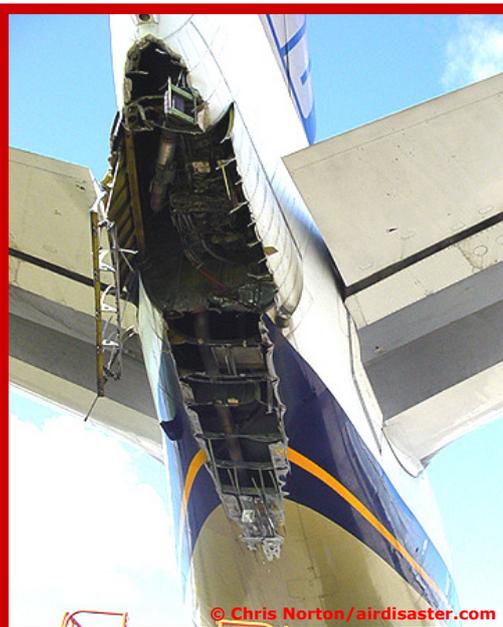
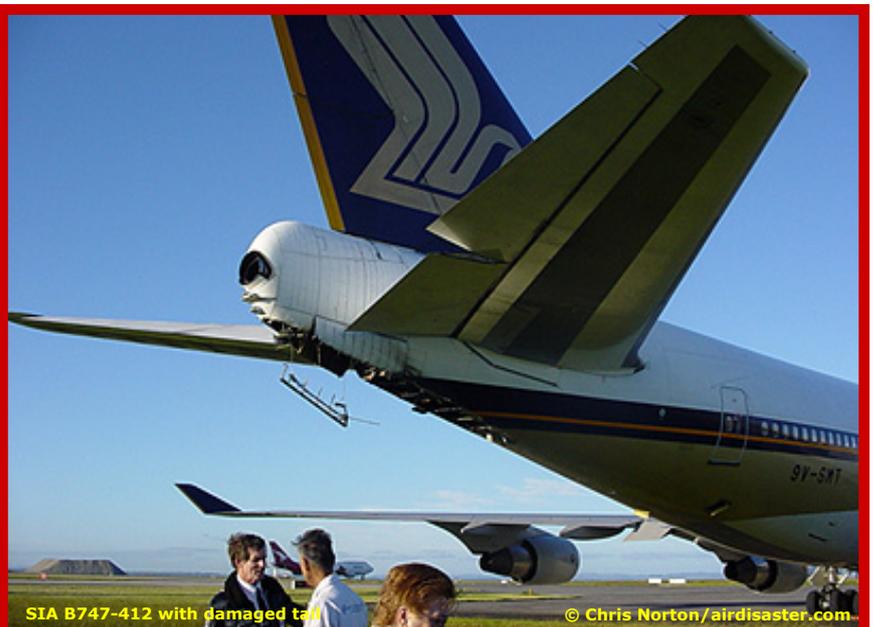
During the takeoff the airplane moved close to the runway edge and the pilots did not respond correctly to a stall warning. There was an APU fire warning and tower controller advised the crew of " a lot of smoke" during the airplane rotation. The crew declared emergency and prudently decided not to dump fuel and made an overweight landing. The tail portion of the fuselage was badly damaged and some parts were dangling outside(See pictures below).

The tail strike occurred because the rotation speed was 33Kt less than the speed required for the airplane weight. The rotation speed was wrongly calculated for an airplane

SIA B747-412 with damaged tail

weighing 100 tons less than the actual weight of 9V-SMT.

1. Establish procedures to ensure independent verification of all essential takeoff data,

2. Reaffirm that safety should not be compromised in the face of delays,

3. Introduce similar errors in recurrent training for pilots to discover, and

4. Develop guidelines for use of the third pilot when one is aboard an airplane designed for two-pilot operation.

b. Boeing: Implement software changes to ensure that weight and V-speeds that are mismatched by a certain percentage are either challenged or prevented.

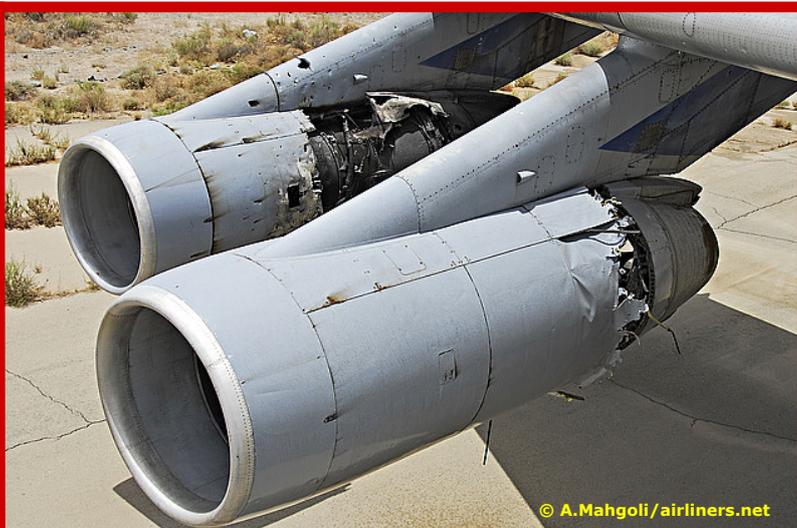
UNCONTAINED ENGINE FAILURE

On July 2,2008, an Ilyushin Il-76TD while flying from Bagram, Iran to Sharjah at FL280 had an uncontained engine failure. No 3 engine exploded and caused damage to engine No 4. The aircraft was flying with 9 crew on board. The photo shows vividly the severity of damage to engine No.4.
