## The Crash of COMAIR RJ at Lexington

On August 27, 2006, about 6:07 a.m. eastern daylight time, COMAIR flight 5191, a Bombardier CRJ-100, N431CA, crashed upon takeoff from Blue Grass Airport in Lexington, Kentucky. The airplane ran off the end of Runway 26. The CRJ was unable to attain sufficient speed for takeoff on the short runway and became airborne briefly before stalling, crashing into a field, and impacting trees about 1/4 mile off the departure end of runway 26. The flight

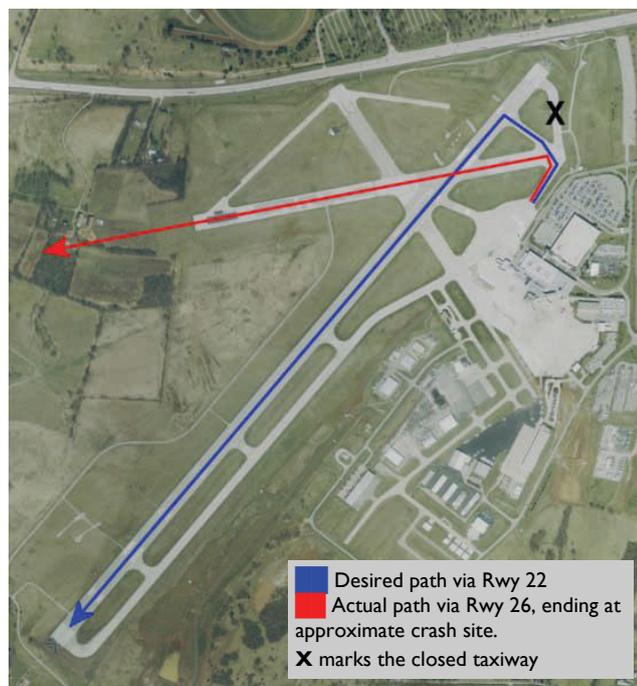
Flight 5191, from Lexington, Kentucky to Atlanta, Georgia was the third of three airplanes scheduled to take off in the early morning. The previous two flights took off without incident from runway 22. Flight 5191 was also cleared to taxi to runway 22 and subsequently cleared to takeoff; however the aircraft attempted take off from runway 26 (see the path marked in the adjacent picture).

As shown in the blue grass airport picture, the taxiway to runway 22 end had been closed due to construction work and the aircraft had to proceed through the end of runway 26 to reach runway 22.

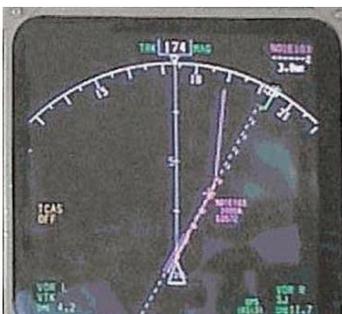
IS THE AIRPLANE SYMBOL SITTING ON THE RUNWAY SYMBOL? IS IT ALIGNED WITH THE INTENDED RUNWAY?

The airplane symbol on the ND should be sitting on the runway symbol on the ND. At this point the ND scale should be set to the smallest possible (e.g. 5Nm). Check that the heading under the Heading Pointer on the ND is the same as the heading set in the Heading Window. If it is not the same, check to see if you have set the

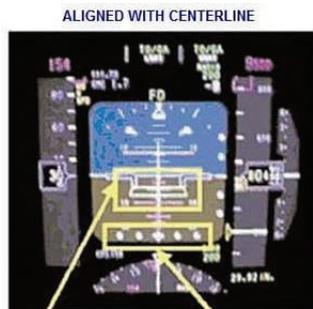
ALIGNED WITH CENTERLINE  
RISING RUNWAY LOCALIZER POINTER & SCALE

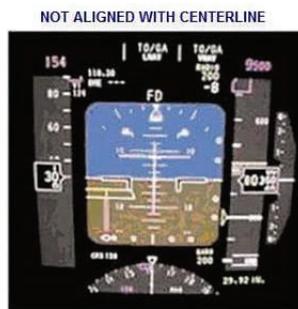
NOT ALIGNED WITH CENTERLINE
