IN THIS ISSUE

UNCONTROLLED ROLL ON TAKEOFF

GROUND DE/ANTI-ICING

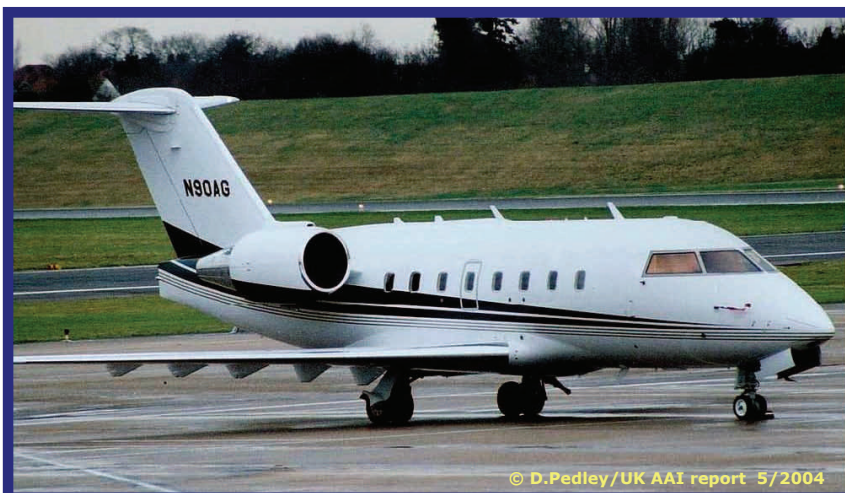
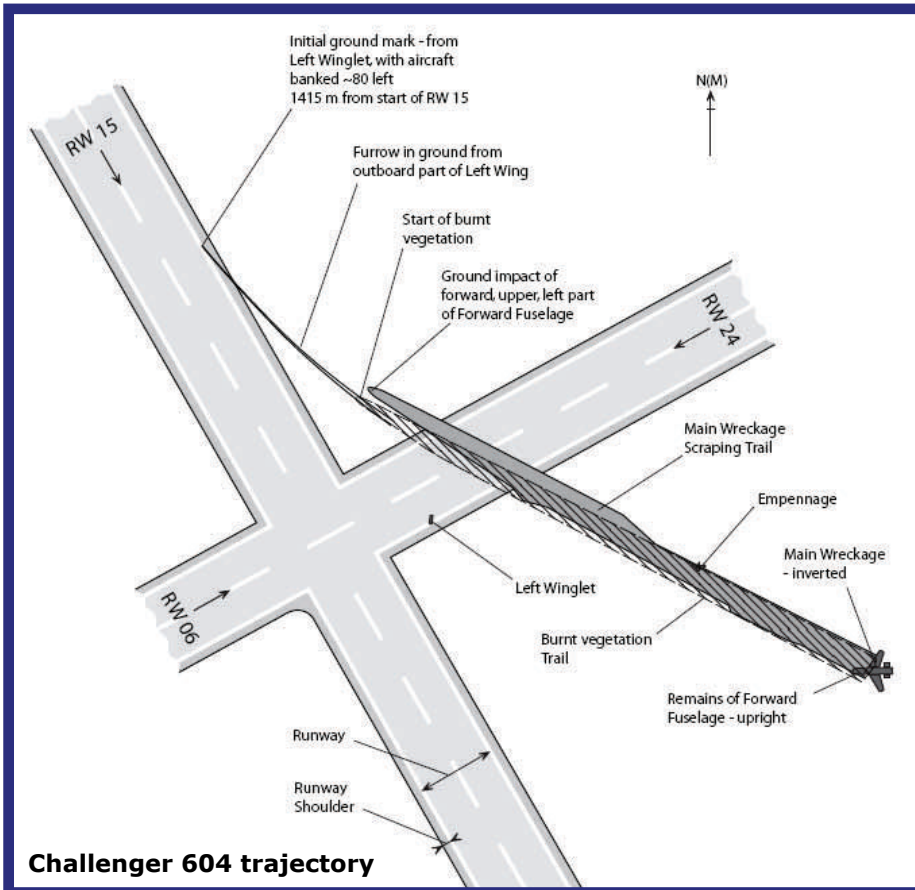
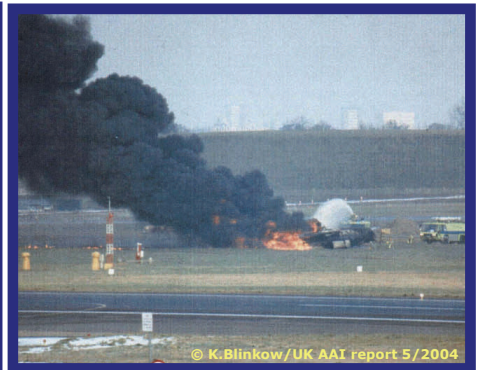
The aircraft was largely destroyed by impact and fire damage (see photo above). All the five onboard died.

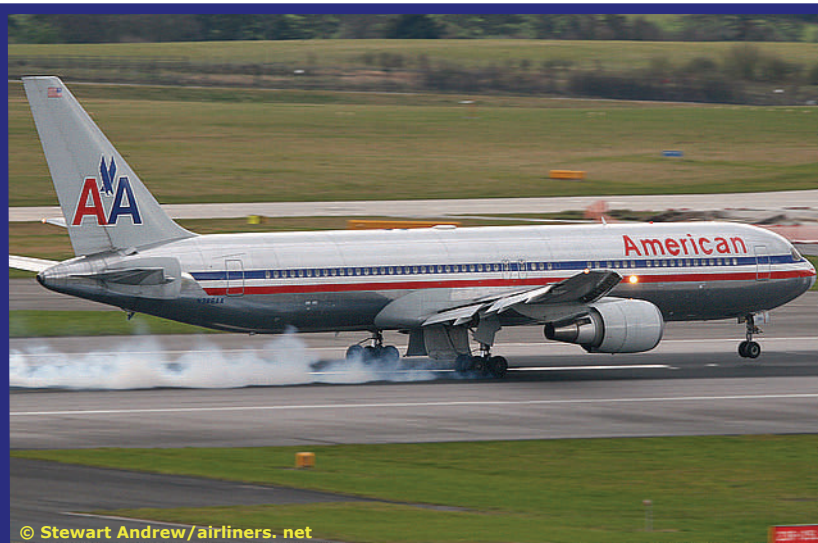
Emergency landing

February 23, 2008, Manchester - International (MAN/EGCC) UK, an American Airlines Boeing 767-323/ER made an emergency landing due to hydraulic failure. The gear doors were stuck down and the fast landing coupled with no nosewheel steering meant the runway was blocked for some time. The aircraft stopped safely but had very hot brakes and a couple of burst tyres.
