FLIGHT SAFETY

AN IN-HOUSE NEWSLETTER OF OPERATIONS DEPT.

October 2007

KUWAIT AIRWAYS FLIGHT KU785 TAIL STRIKE DURING LANDING AT JEDDAH

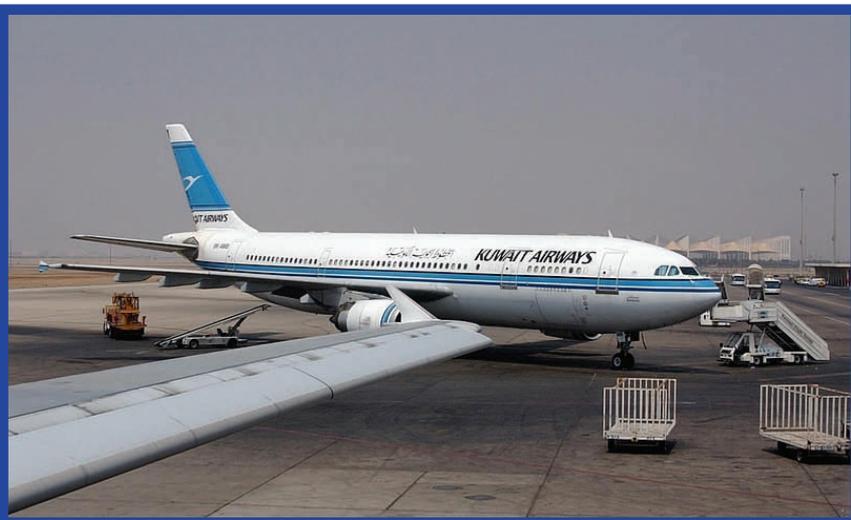
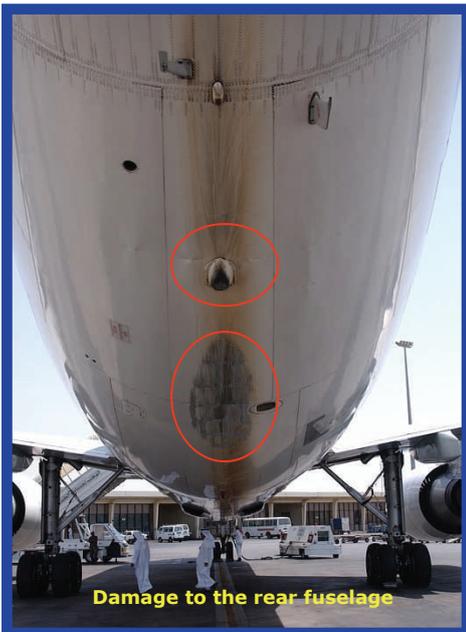
height of over 5 ft. The crew attempted to control the second landing by increasing the pitch attitude. The aircraft made a hard touchdown with high pitch attitude resulting in tail strike. Landing continued down to taxi speed and the aircraft taxied to the parking stand.

The station ground engineer observed the intensive damage to the lower part of the tail section of the fuselage(see pictures in page 2) and reported to the crew. The damage to the aircraft included— Severe damage to the aft fuselage structural frame #77; sheared rivets on frame #77; Badly scratched and cracked outer skin; tail skid abrasion shoe worn beyond orange marking; failure of 3 support rods between frame #77 and cross beam.

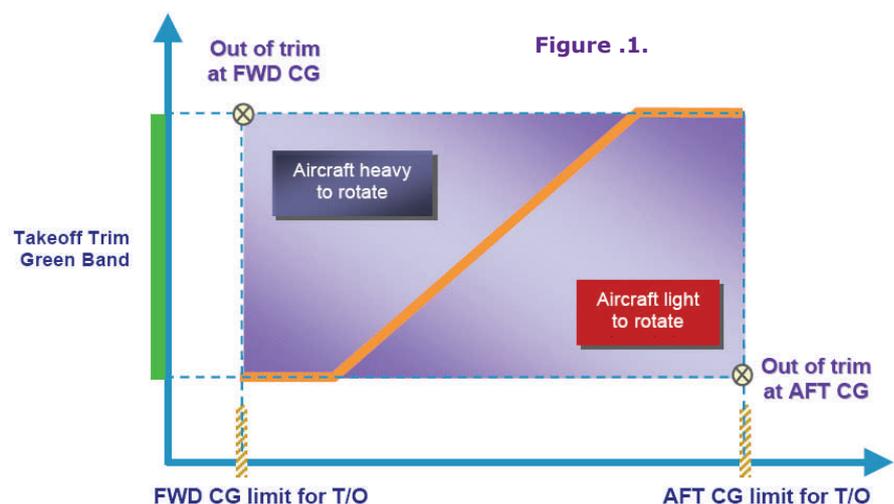
The main purpose of the pitch trim setting for takeoff is to provide consistent rotation characteristics. If, for any reason, the trim setting does not match the CG position, the aircraft will not rotate as usual (see Figure 1):

With a forward CG or the pitch trim erroneously set to the nose-down direction, the flight crew will notice that the aircraft is "heavy to rotate", and that aircraft rotation will be very slow in response to the usual takeoff control input

With an aft CG or the pitch trim erroneously set to the nose-up direction, the flight crew might have to counteract an early autorotation, until Vr is reached.

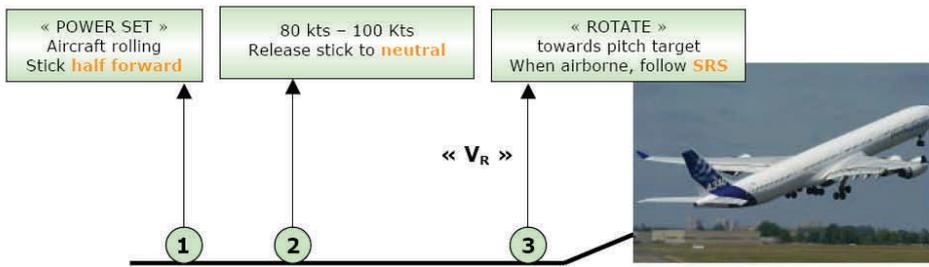
Typical takeoff sequence

The takeoff sequence figure in the next page indicates the sequence for a standard takeoff. However, flight crewmembers should keep in mind that this sequence can vary depending on the scenario (e.g. Windshear), and the PF should be ready to react in any abnormal situation.

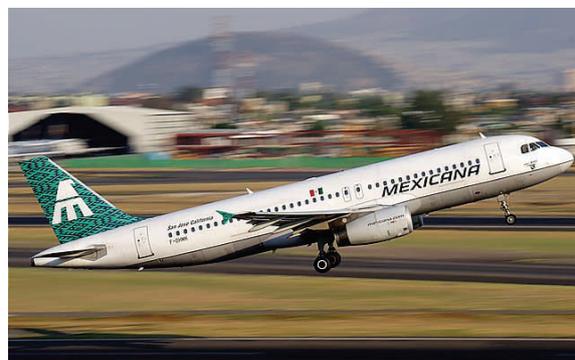
Mexicana A320 tail strike

In May 2005, at the Licenciado Benito Juarez International, Mexico City (MEX/MMMX) Mexico, a Mexicana Airbus A320-231 had a powerful rotation during takeoff resulting in a tail strike.
