خطوط الكويت الجوية
KUWAIT AIRWAYS

FLIGHT SAFETY BULLETIN

FOR QUICK DISSEMINATION OF AVIATION NEWS
NO.1, NOVEMBER 2007

Nationwide Boeing 737 Engine separation during takeoff

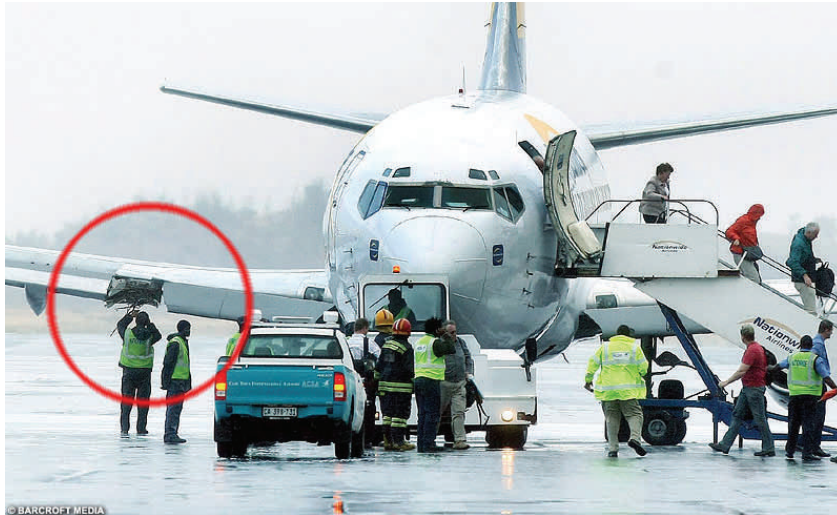
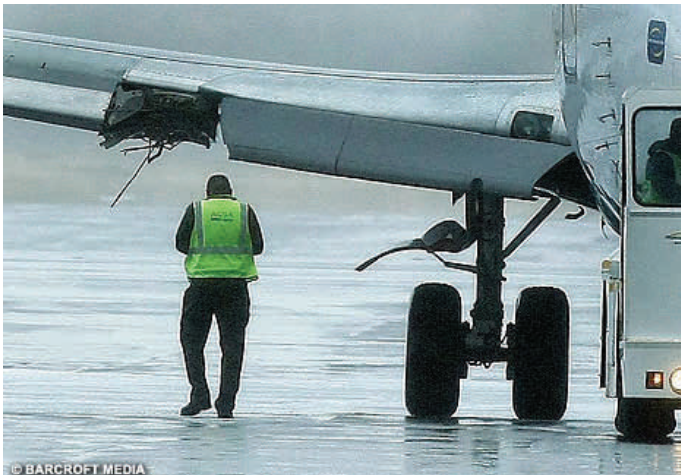
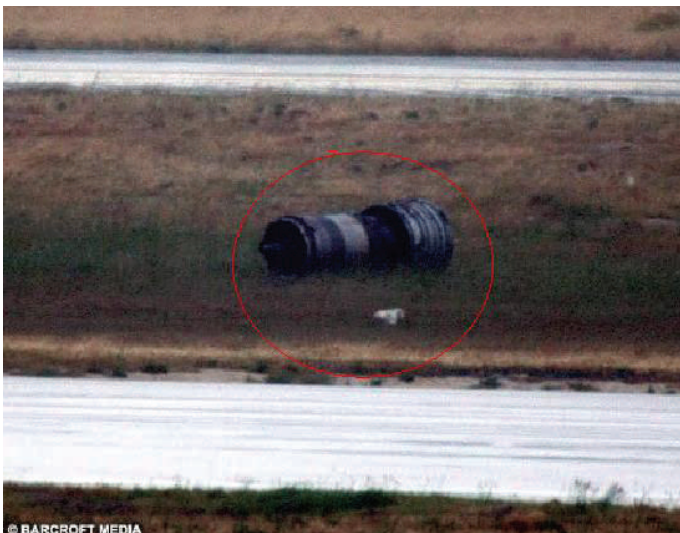
On Nov.7, 2007, Nationwide Airlines Flight CE723, a Boeing 737-200 departed from Cape Town (CPT) to Johannesburg on schedule at 15:50. At take-off it was reported that the right hand engine separated from the wing. The aircraft was continuing to climb as debris fell to the ground.

South African aviation authorities have grounded all Boeing 737-200 aircraft in the country for safety checks.

The order affects all Boeing 737s fitted with Pratt and Whitney JT8D engines. It is aimed at preventing the possibility of a similar accident happening and is not an indication of the cause of the accident, the authorities said.
