Engine failure on Malaysian Boeing 777-200ER over Stockholm

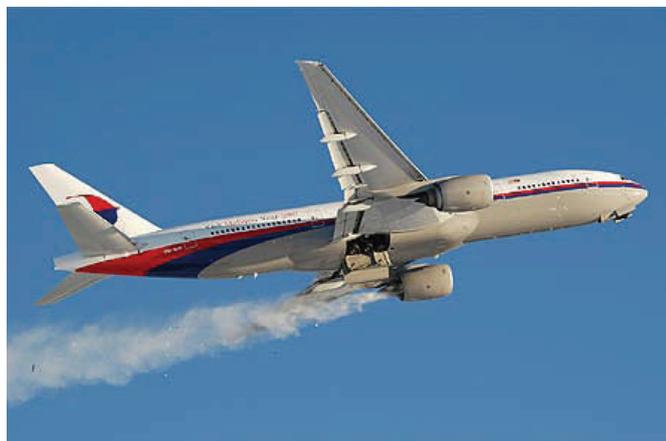
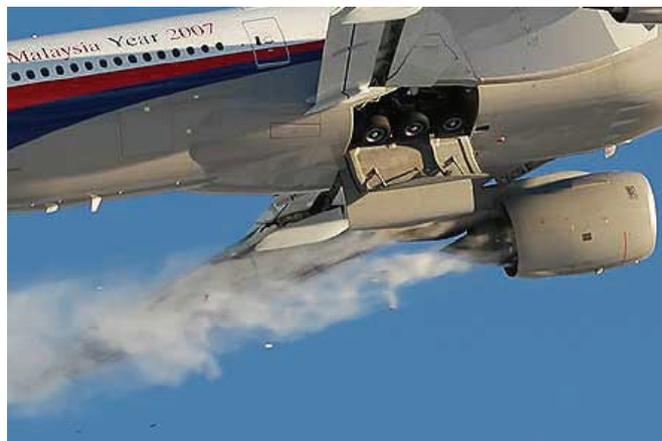
On Friday Nov.4, 2006, the Malaysian Boeing 777-200ER (9M-MRI) en route back to Kuala Lumpur as flight MH091 from New York Newark had to return shortly after takeoff from Stockholm Arlanda airport due to engine problem. The aircraft, with 279 passengers on board, suffered the failure on take-off (see pictures above) before continuing to go around 8,000ft (2,700m) to dump fuel. The aircraft landed without problems.

Unconfirmed details from maintenance workers at Arlanda indicate that the inner wall of the Rolls-Royce Trent 800's D Duct disintegrated on rotation, leading to glass fibre debris being exited from the engine. The left flaperon also suffered impact damage. Further speculation continues that the fan air stream pushed the exhaust nozzle into the core exit and the engine surged. The crew pulled controls back to idle, but had no cockpit indications, it is understood. After dumping 60t of fuel, the engine was left running at idle until the 777 landed.

Initial inspections teams from Boeing Seattle and from R-R have concluded that blade delamination on the core of the reverser was the probable cause, as per the maintenance provider at Arlanda. No engine defect or operational issue was found by preliminary inspections.
