# FLIGHT SAFETY

Vol.2, No.6

June 2007

## MK AIRLINES B747 REDUCED POWER TAKE-OFF AND COLLISION WITH TERRAIN

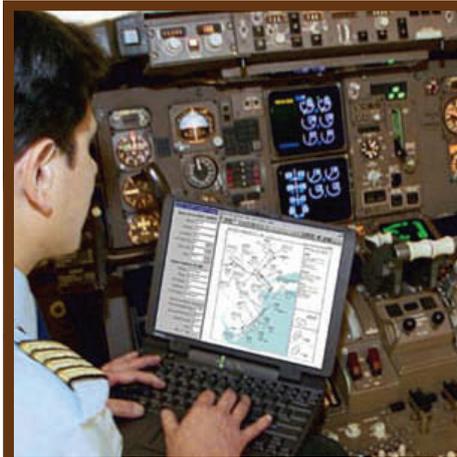
On the loadmasters page, the notice said "When closing weight-and-balance page, the takeoff weight as listed in the weight-and-balance page will now appear in the planned takeoff weight block." This was not included in the instruction for pilots.

The Boeing Laptop Tool (BLT)

The notice also asked flight crew members to read the instructions in the BLT manual. The report said that "it could not be ascertained whether the crew of flight 1602 had read the BLT manual issued in February or the simplified one issued in March." Report from other crew members indicated that the operating captain was not comfortable using BLT, while the first officer had been using it.
