## The Crash of COMAIR RJ at Lexington

On August 27, 2006, about 6:07 a.m. eastern daylight time, COMAIR flight 5191, a Bombardier CRJ-100, N431CA, crashed upon takeoff from Blue Grass Airport in Lexington, Kentucky. The airplane ran off the end of Runway 26. The CRJ was unable to attain sufficient speed for takeoff on the short runway and became airborne briefly before stalling, crashing into a field, and impacting trees about 1/4 mile off the departure end of runway 26. The flight

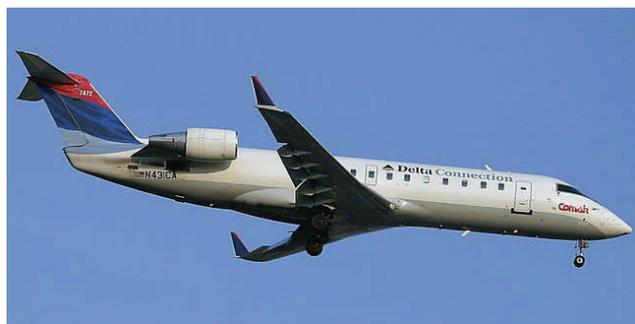
Flight 5191, from Lexington, Kentucky to Atlanta, Georgia was the third of three airplanes scheduled to take off in the early morning. The previous two flights took off without incident from runway 22. Flight 5191 was also cleared to taxi to runway 22 and subsequently cleared to takeoff; however the aircraft attempted take off from runway 26 (see the path marked in the adjacent picture).

As shown in the blue grass airport picture, the taxiway to runway 22 end had been closed due to construction work and the aircraft had to proceed through the end of runway 26 to reach runway 22.
