FLIGHT SAFETY

AN IN-HOUSE NEWSLETTER OF OPERATIONS DEPT.

October 2007

KUWAIT AIRWAYS FLIGHT KU785 TAIL STRIKE DURING LANDING AT JEDDAH

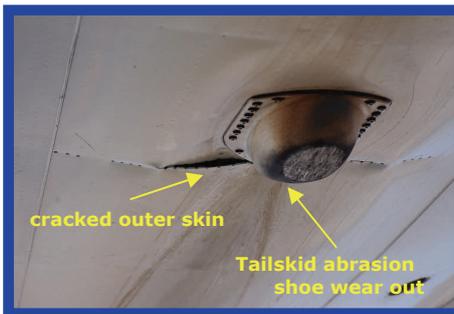
The aircraft landed with a descent rate of 450 ft/min and a pitch attitude of 9.5° nose up resulting in a bounce. After the bounce, the PF did not apply the correct recovery technique given in FCOM. Instead he continued with the pitch up command resulting in aircraft pitch of +12.4° leading to tail strike. (with main landing gear fully compressed, tail strike occurs at a pitch of +11.4°)

Notwithstanding the losses due to the nonavailability of the aircraft for operations, the repair costs arising out of this tail strike was around US \$ 2.6 million.
