FLIGHT SAFETY

AN IN-HOUSE NEWSLETTER OF OPERATIONS DEPT.

Vol.5, No.3 Flight Safety & Quality Assurance Division March 2010

<i>Qantas A-330-300 In-flight upset</i>	1
<i>Loss Of Control in flight (LOC-I)</i>	3
<i>BA Boeing777 crash investigation—Final report</i>	5
<i>Crew Incapacitation</i>	6
<i>Photo of the month</i>	6

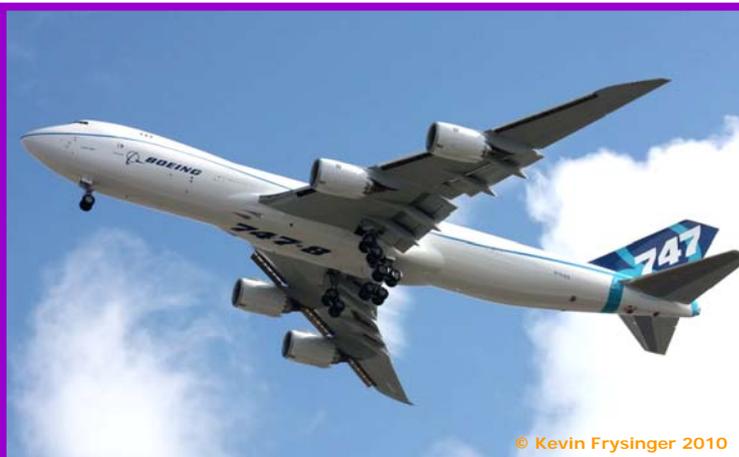
On February 8, Boeing 747-8 Freighter took to the sky at 12:39 p.m. local time from Paine Field in Everett and landed at Paine Field at 4:18 p.m. It underwent tests for basic handling qualities and engine performance. The airplane reached a cruising altitude of 17,000 ft and a speed of up to 230 knots. Two more test airplanes will join it in the coming month.

The 747-8 Freighter is the new, high-capacity 747 that will give cargo operators the lowest operating costs and best economics of any freighter.
