# FLIGHT SAFETY

AN IN-HOUSE NEWSLETTER OF OPERATIONS DEPT.  
KUWAIT AIRWAYS CORPORATION

Issue 6, April 2006

## B777 Fire Incidents

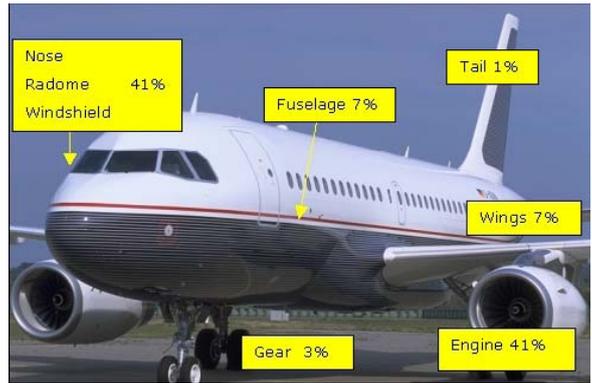
- One out of five Birdstrike causes damage to the aircraft.
- Two birdstrikes out of three cause either a delay of an hour and a half for aircraft and engine check, or a longer delay for engine change or structure repair.
- Following a Birdstrike during takeoff or climb, one aircraft out of three does not fly to destination (RTO, IFTB or diversion).
- Birdstrike on the radome can significantly increase fuel consumption as there will be an increase in drag.
