# FLIGHT SAFETY

AN IN-HOUSE NEWSLETTER OF OPERATIONS DEPT.

Vol.2, No.12 Flight Safety & Quality Assurance Division December 2007

## AIR FLORIDA B737 CRASH

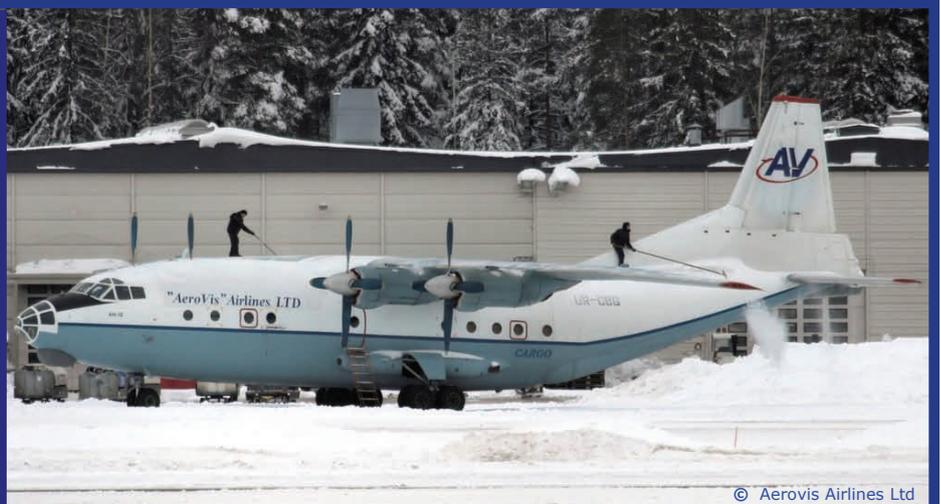
AeroVis Airlines (Rovno) of the Ukraine has a different approach to dealing with the tough winter flying conditions.

After a snowstorm the crew came to prepare the aircraft for the next flight. They found some long brushes and cleaned the aircraft of snow and ice and they were ready to go! A simple eco-friendly method as no chemicals are involved!
