## HIGH-ALTITUDE JET ENGINE POWER-LOSS

Several engine power-loss and damage events have occurred in convective weather above altitudes typically associated with icing conditions. "Power-loss" is defined as engine instability such as a surge, stall, flameout, or rollback that results in a sub-idle operating condition.

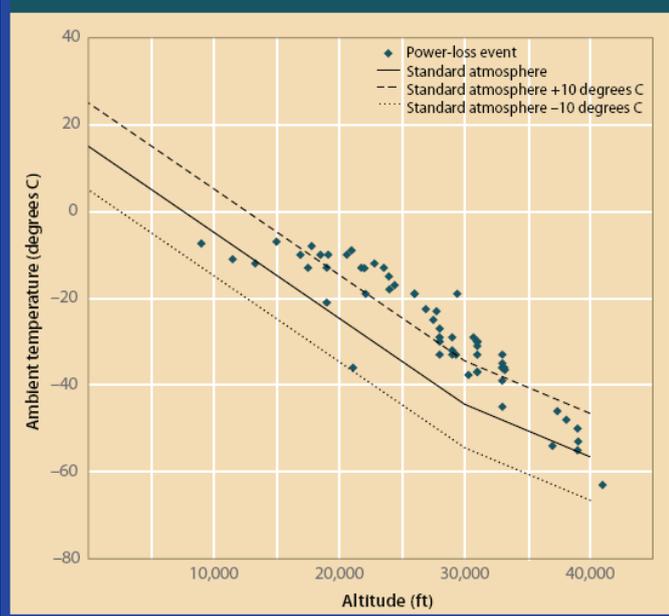
Power-Loss Event Altitudes and Temperatures

Commercial aircraft power-loss events associated with ice crystals have occurred at altitudes of 9,000 to 39,000ft, with a median of 26,800ft, and at ambient temperatures of  $-5^{\circ}\text{C}$  to  $-55^{\circ}\text{C}$  with a median of  $-27^{\circ}\text{C}$ . The diagram below shows events shown on altitude-ambient temperature. The engine power-loss events generally occur on days when the ambient temperature is warmer than the standard atmosphere.
