FLIGHT SAFETY

Vol.4, No.12 Flight Safety & Quality Assurance Division December 2009

Take off Securing Function (TOS)	1
Press-on-itis	5
Photo of the month	6

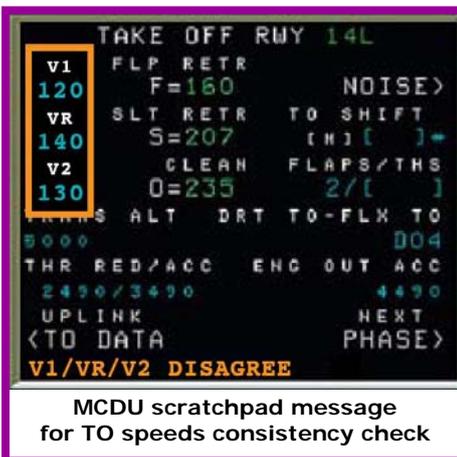
Take-Off speeds consistency check is performed as soon as all Take-Off speeds are inserted in the PERF take-off page, or each time a take-off speed is modified.

When the condition $V1 \leq VR \leq V2$ is not satisfied, a "V1/VR/V2 DISAGREE" caution message will appear on the MCDU scratchpad.

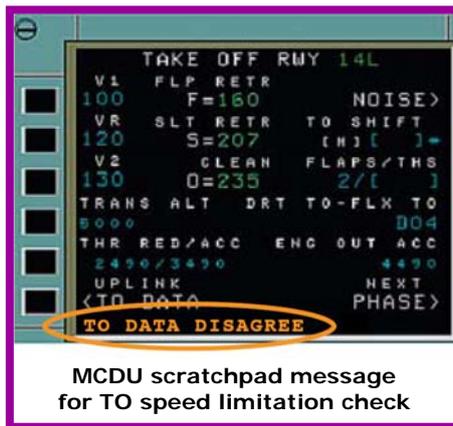
- ZFW, BLOCK and CONF are entered on the MCDU
- ZFW, BLOCK, CONF or take-off thrust setting are modified
- Engines are started.

In case of an abnormal TO speed, the "TO DATA/TOW DISAGREE" caution message appears on the MCDU scratchpad.

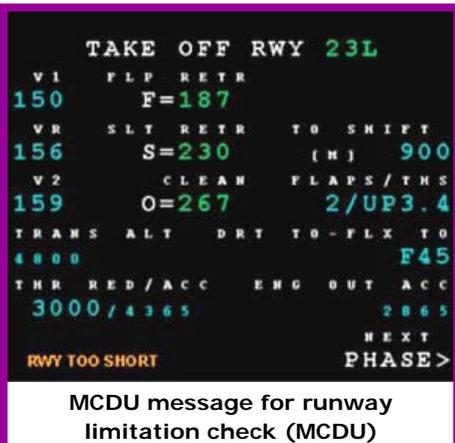
- During the pre-flight phase, the system checks for the consistency of the inserted TO data with the planned departure runway. The estimated lift-off run distance is compared with the distance available on the runway (including TO shift).

MCDU message for runway limitation check (MCDU)

If the system detects a risk of runway overrun during the pre-flight phase, a caution message is displayed on both the MCDU scratchpad and the ECAM.

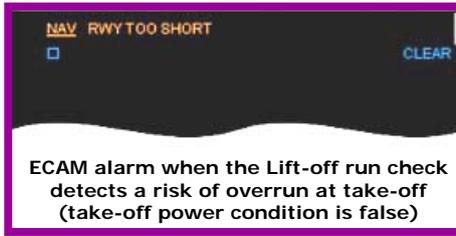
ECAM alarm when the Lift-off run check detects a risk of overrun at take-off (take-off power condition is false)

If the system detects a risk of runway overrun during the take-off phase (thrust levers set in a position higher than the Climb (CLB) detent), a "RWY

"TOO SHORT" warning is displayed on the ECAM and a single chime aural alert is triggered.

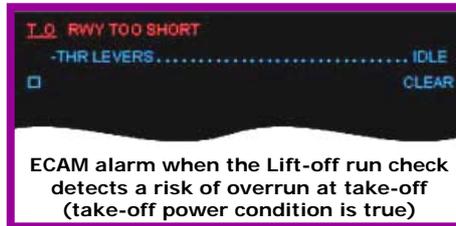
ECAM alarm when the Lift-off run check detects a risk of overrun at take-off (take-off power condition is true)

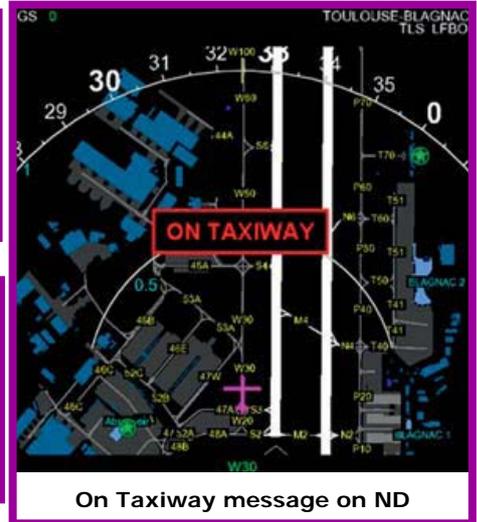
If the aircraft is not on a runway, an "ON TAXIWAY" warning is displayed on the Navigation Display (ND) (all the ranges are concerned) and an "ON TAXIWAY!" specific aural alert is triggered.

On Taxiway message on ND

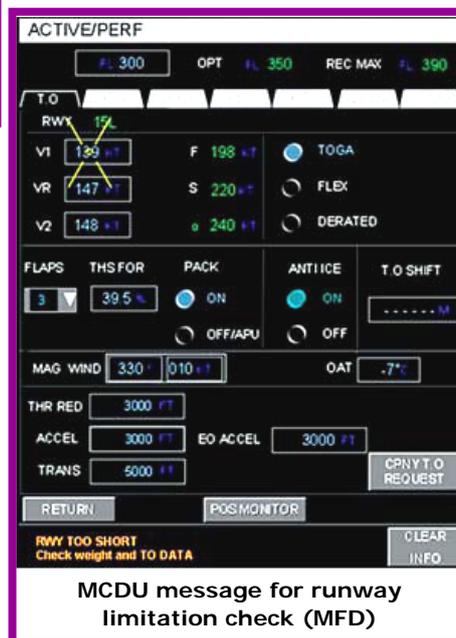
MCDU message for runway limitation check (MFD)

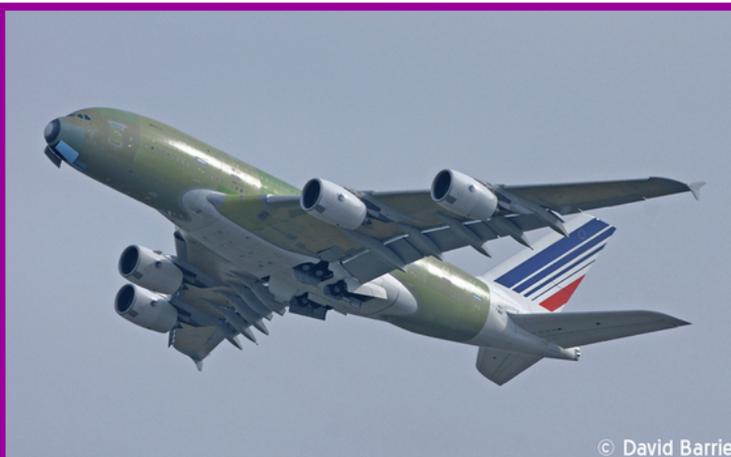
February 16, 2009, Toulouse. Air France's first A380 took off to Hamburg from Toulouse for painting and cabin outfitting. The unpainted fuselage and wing reveals the massiveness of the aircraft, unlike a fully painted one.
