## IN THIS ISSUE

## EDITORIAL

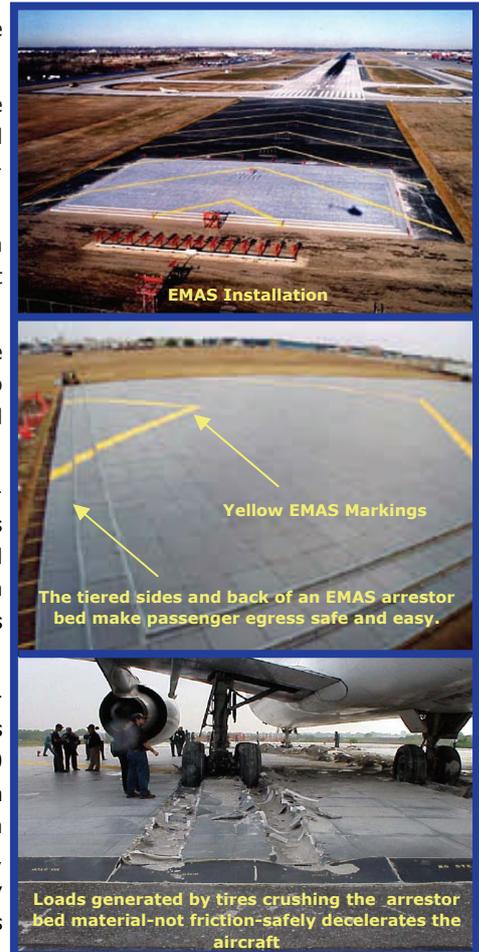
EMAS is a bed of crushable cellular cement blocks placed at the end of runway. Each block is affixed to the pavement with a hot asphaltic mix, forming an arrestor bed to decelerate an overrunning aircraft in emergency. It is a passive system that reliable and predictably gets crushed under the weight of an aircraft. EMAS does not cause damage to the aircraft.

To date, there have been four successful commercial aircraft arrestments for the ESCO-EMAS system: a Saab 340 commuter aircraft in May 1999, an MD-11 cargo aircraft in May 2003, a B747 cargo aircraft in January 2005, and a Falcon 900 business jet in July 2006. The first three arrestments occurred at JFK International Airport in New York, and the fourth was recorded at Greenville Downtown Airport in South Carolina. In all cases, the arrestments were successful, with no injuries or significant damage to the aircraft reported.

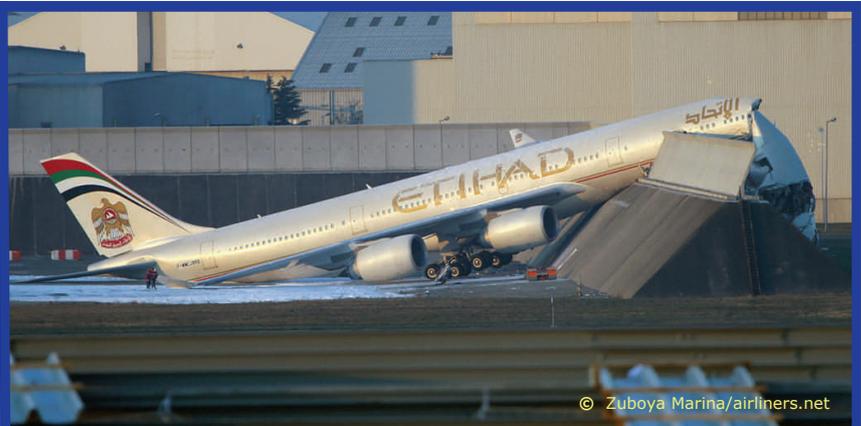
On 15th November 2007, at Airbus production facilities in Toulouse, an Airbus A340-600 due to be delivered to Etihad Airways was involved in an incident.

According to Airbus, the aircraft had completed final engine run and was exiting the engine run zone when it impacted a containment wall and was severely damaged. Of the nine persons onboard, five were injured.
