# FLIGHT SAFETY

AN IN-HOUSE NEWSLETTER OF OPERATIONS DEPT.

Vol.3, No.5

## MID-AIR COLLISION AT CHARKI DADRI

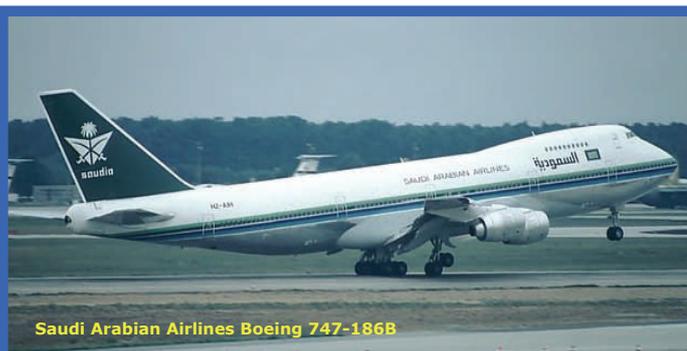
Saudi Arabian Airlines Boeing 747-186B

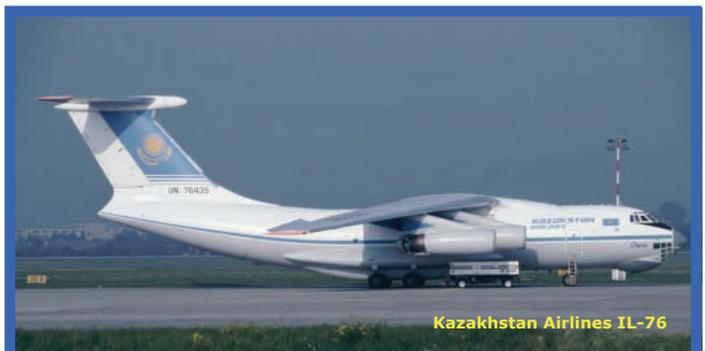
Kazakhstan Airlines IL-76

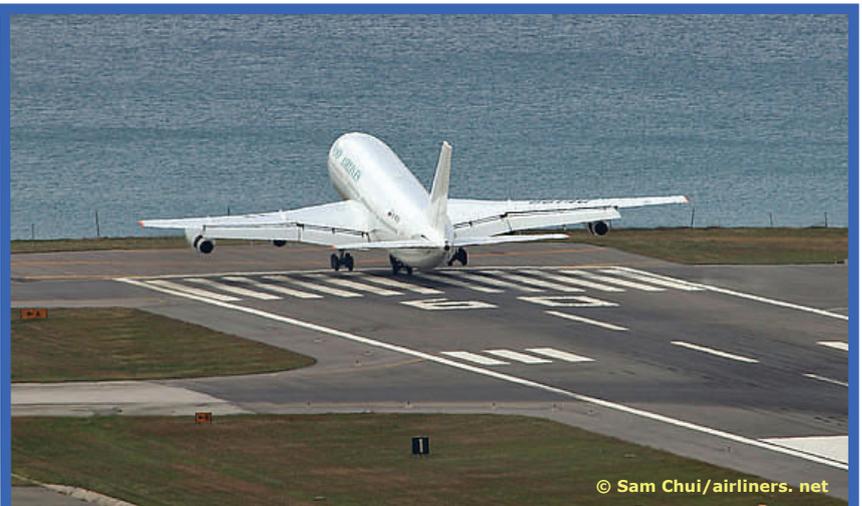
A Vaso Airlines Ilyushin IL-86 takes off with hardly any runway left.

See where the 1000 ft marker sign is and where the plane is! No more runway left means "must rotate!!" The pilots know exactly where to rotate!!
