FLIGHT SAFETY

AN IN-HOUSE NEWSLETTER OF OPERATIONS DEPT.

Flight Safety & Quality Assurance Division

September 2007

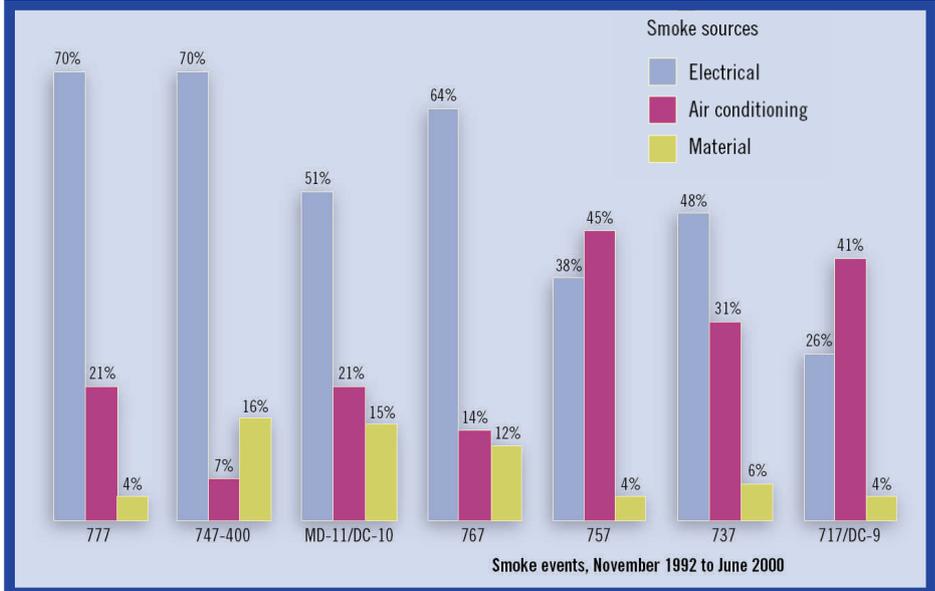
Boeing performed an analysis of all reported events involving smoke, fumes, fire, and overheating in the pressurized areas of its airplanes between Nov. 1992 and June 2000.

For this study, the events were categorized into three classes: air conditioning, electrical, and material. The term **smoke** here refers to odors, smells, fumes, or overheating as well as visible

smoke.

- Air-conditioning smoke events were cases in which incoming bleed air was contaminated, perhaps from engine oil or contaminated outside air.

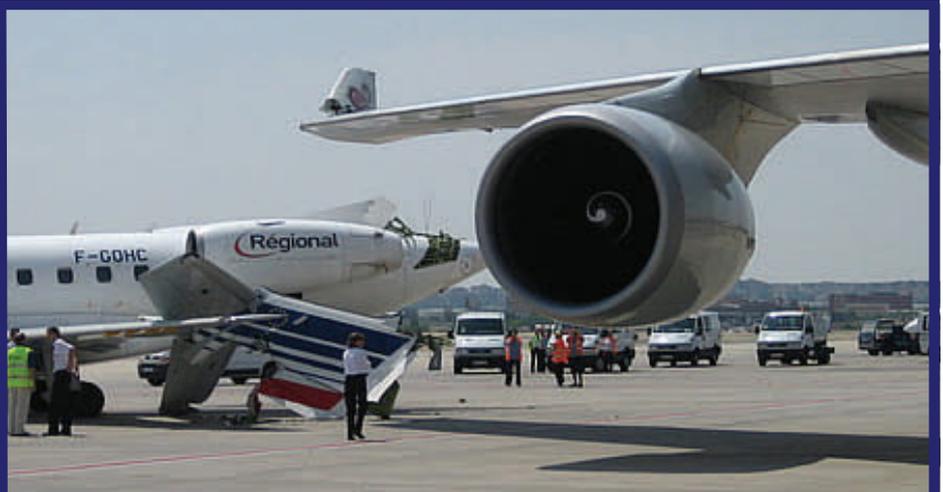
At the airport in Madrid - Barajas (MAD/LEMD), Spain, a Thai 747 was taxiing on a taxiway open to aircraft not bigger than an A321, with a spectacular result!

See the fate of the Air France Embraer Regional jet vertical tail. Jumbo Wing did a good slicing job?!
