HIGH-ALTITUDE JET ENGINE POWER-LOSS

Adopted from Jeanne Mason's article "Engine Power Loss in Ice Crystal conditions" in Boeing Aero Qtrly. 04/07

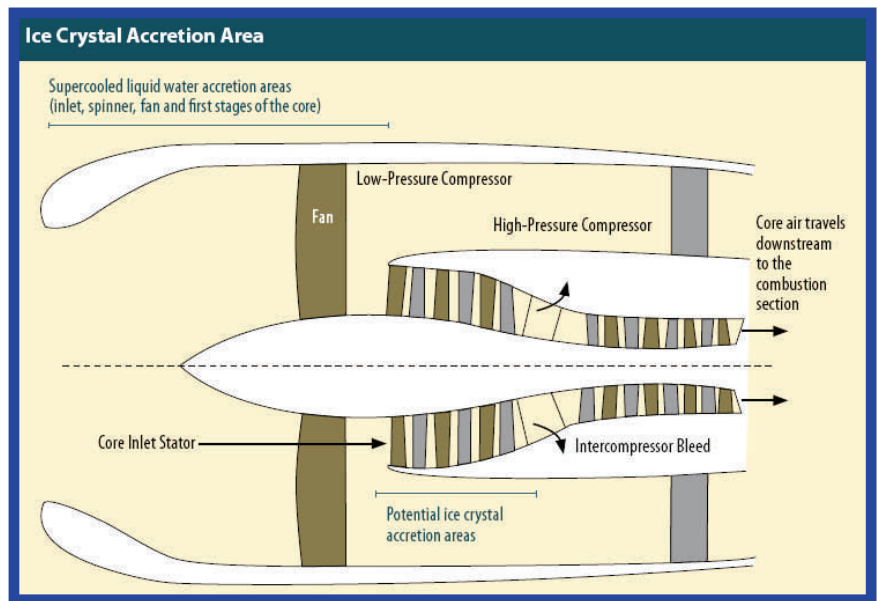
About 60 percent of recorded ice crystal power-loss events have occurred in Asia. This may be due to the fact that the highest sea surface temperatures occur in this region. Higher temperature air can hold more water. There is a heavy concentration of ice crystal

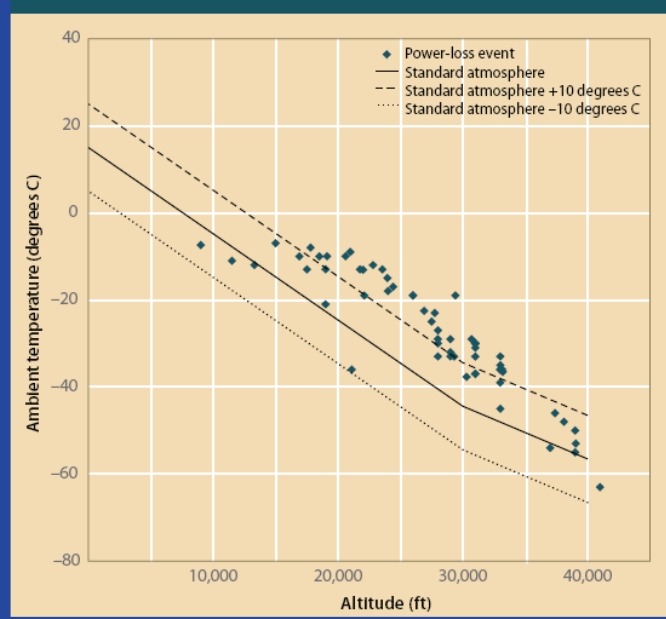
Power-Loss Event Altitudes and Temperatures

Commercial aircraft power-loss events associated with ice crystals have occurred at altitudes of 9,000 to 39,000ft, with a median of 26,800ft, and at ambient temperatures of -5°C to -55°C with a median of -27°C . The diagram below shows events shown on altitude-ambient temperature. The engine power-loss events generally occur on days when the ambient temperature is warmer than the standard atmosphere.

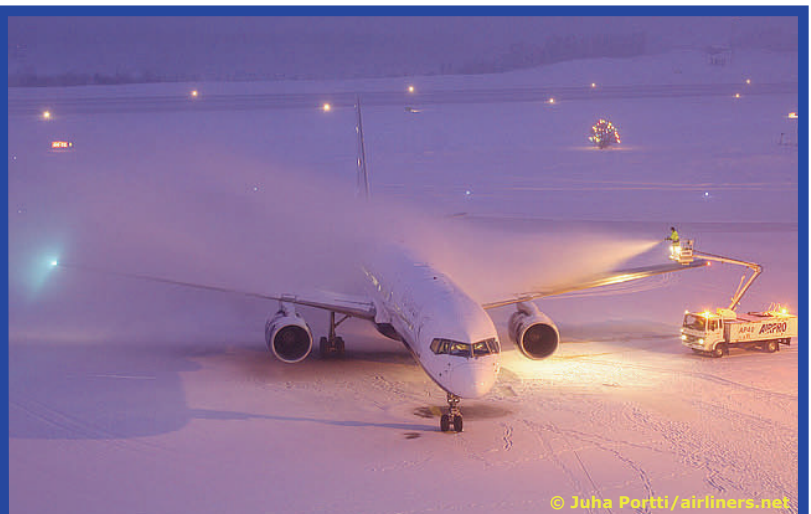
Dec.08, 2006, Ivalo (IVL/EFIV), Finland
Monarch Airlines Boeing 757-2T7, G-MONB
De-icing in progress in a heavy snowfall.
