A320 Spoiler Disconnection

Bird strike on a B767

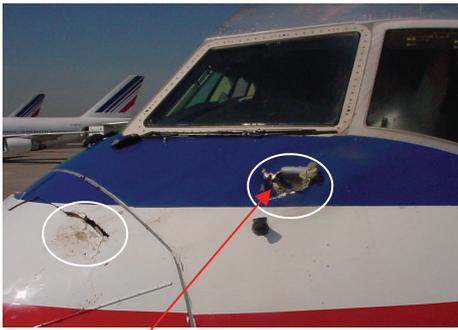
Through this, the bird entered the cockpit

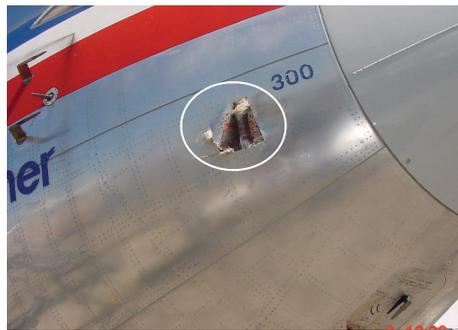
Damage on the front fuselage starboard side

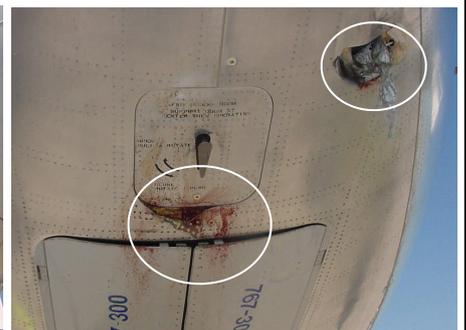
Damage on the front fuselage port side

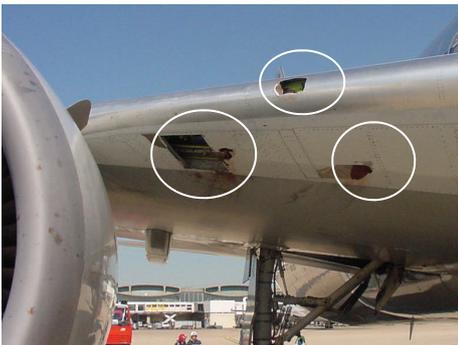
Damage on starboard wing

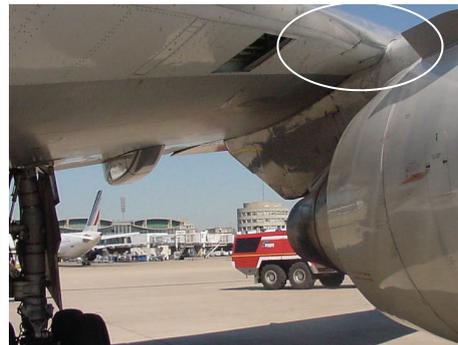
Damage on port wing leading edge

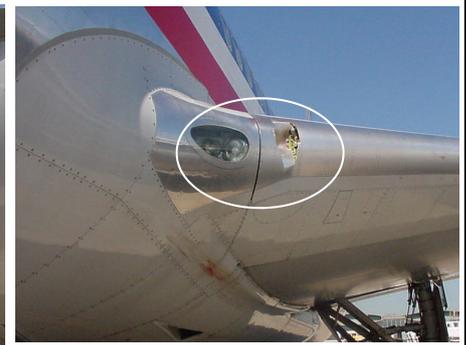
Damage on port wing—near root
